F-4C/D LIFE EXTENSION PROGRAM

Robert L. Schneider
Structures Test Branch
Structures and Dynamics Division

October 1982

Final Report for Period October 1974 - May 1981

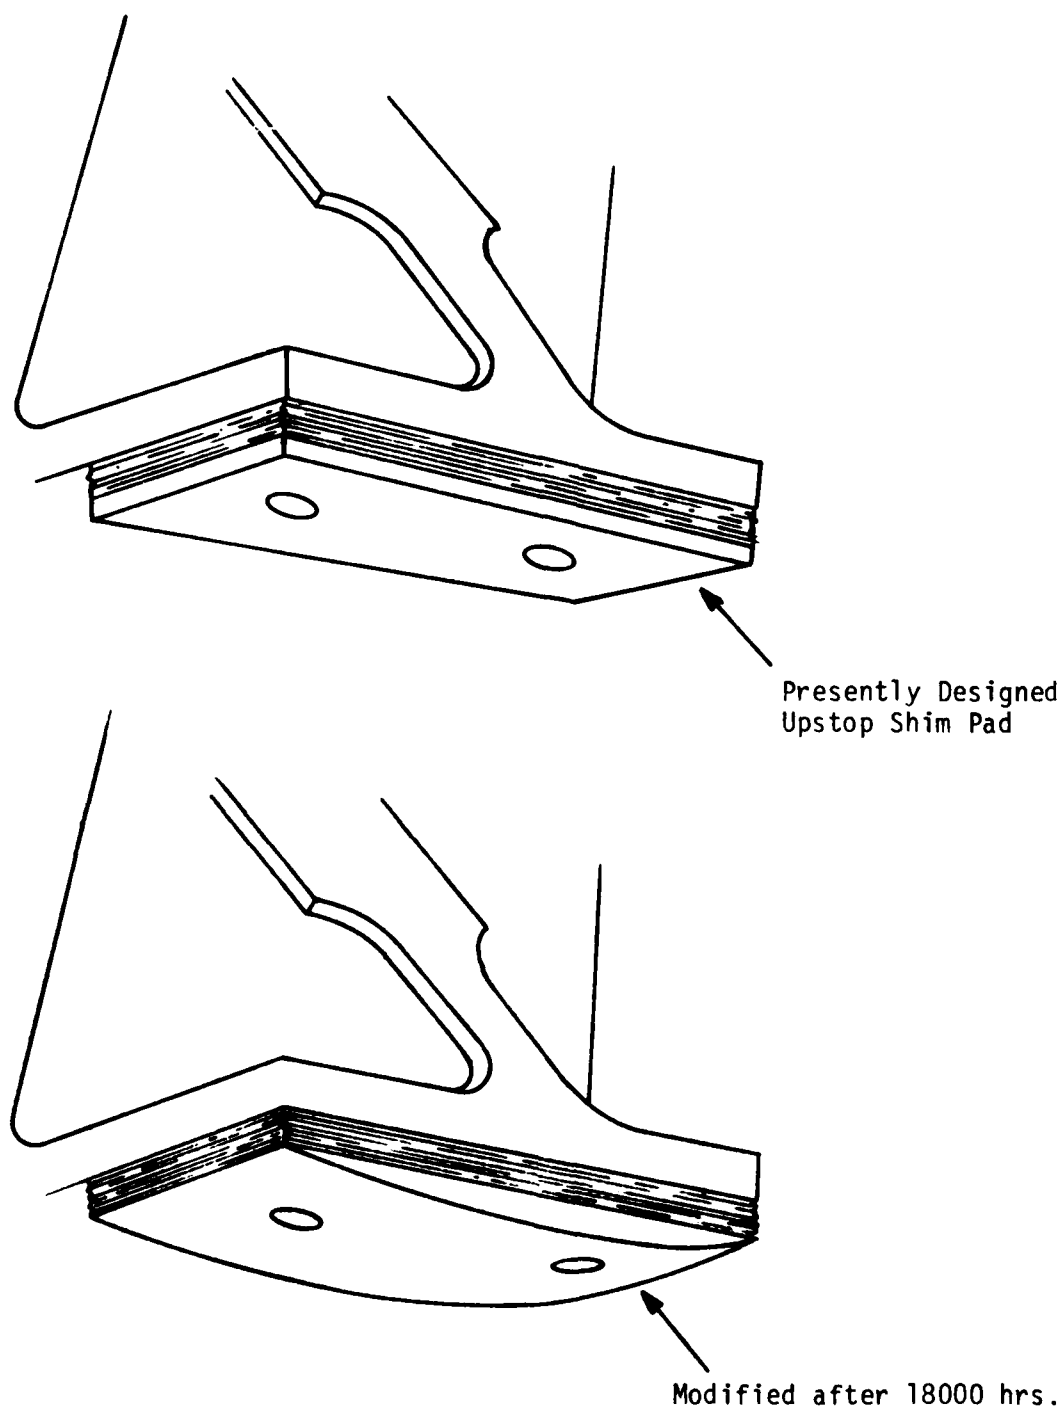
Figure 27. Upstop Modification

The flap upstop failed repeatedly and was replaced every 2000 hours. This failure constituted no major problem to the aircraft but remains a considerable nuisance in the maintenance of the aircraft. After 18,000 hours of testing, the flap upstop shims were modified and installed in the test aircraft (Figure 27). No further failures of the upstop occurred.

The rounded fore and aft edges assure that the upstop load is applied close to the middle of the pad and therefore reduces the bending associated with off center loads.

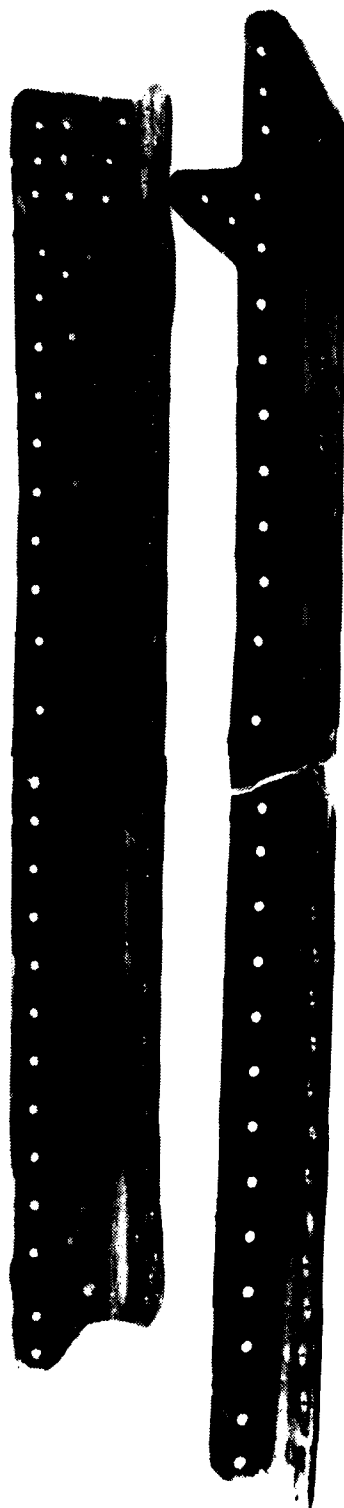
Figure 28. Speed Brake Failure

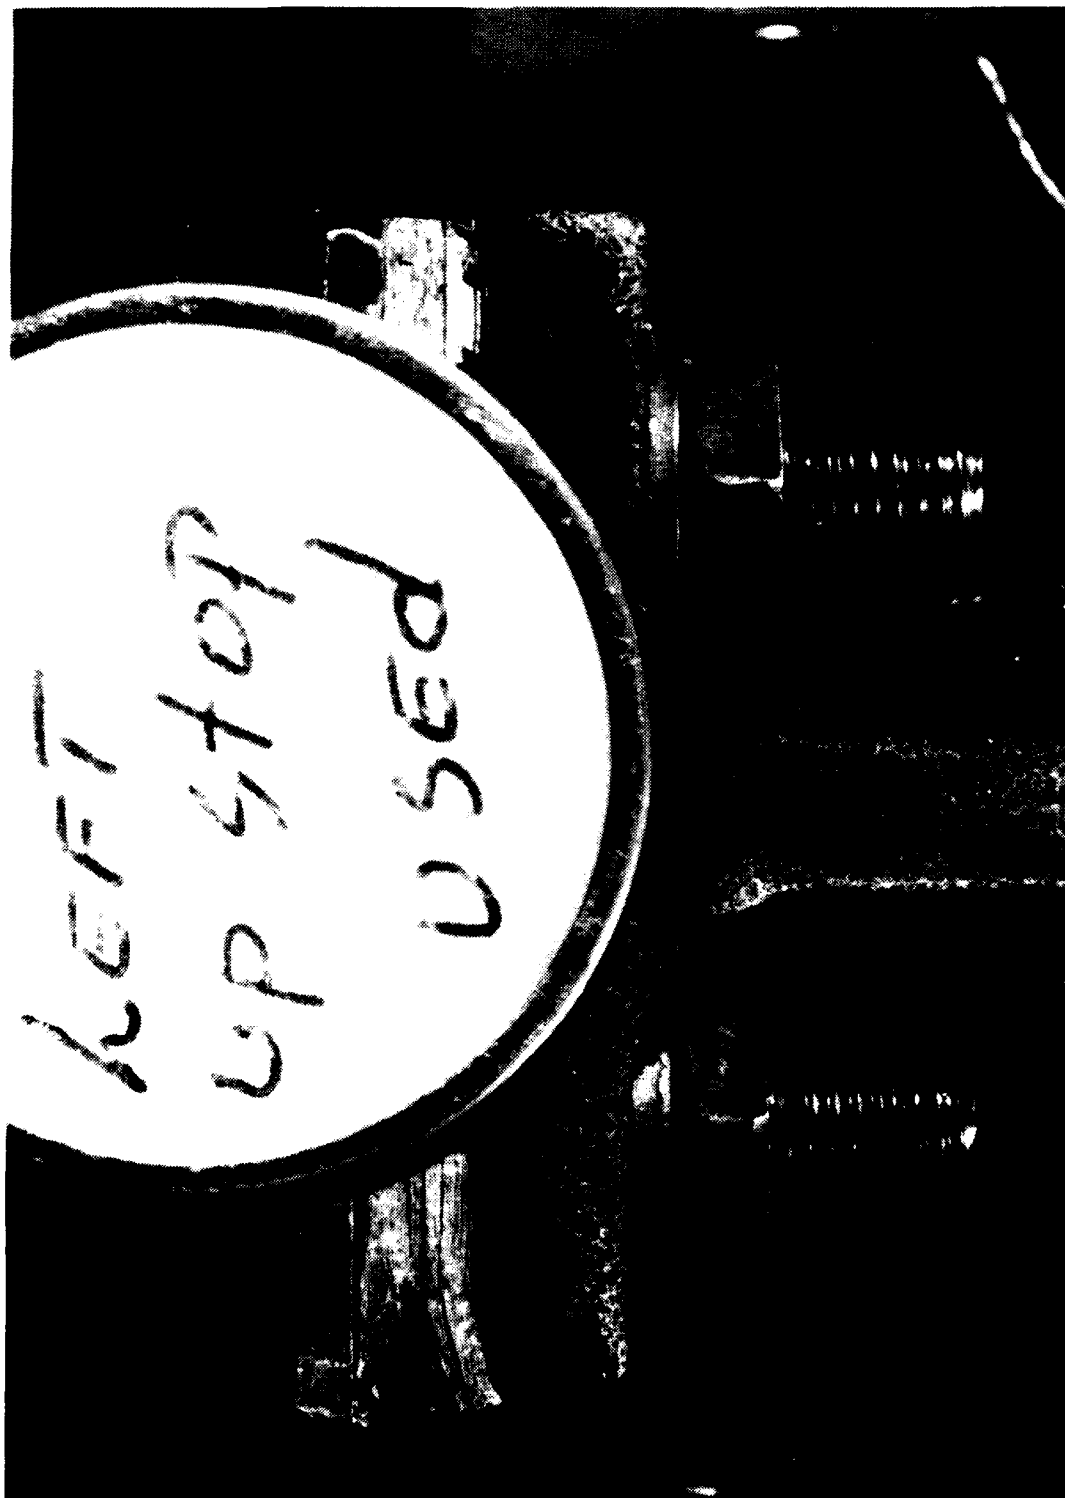
Figure 29. Upstop Failure

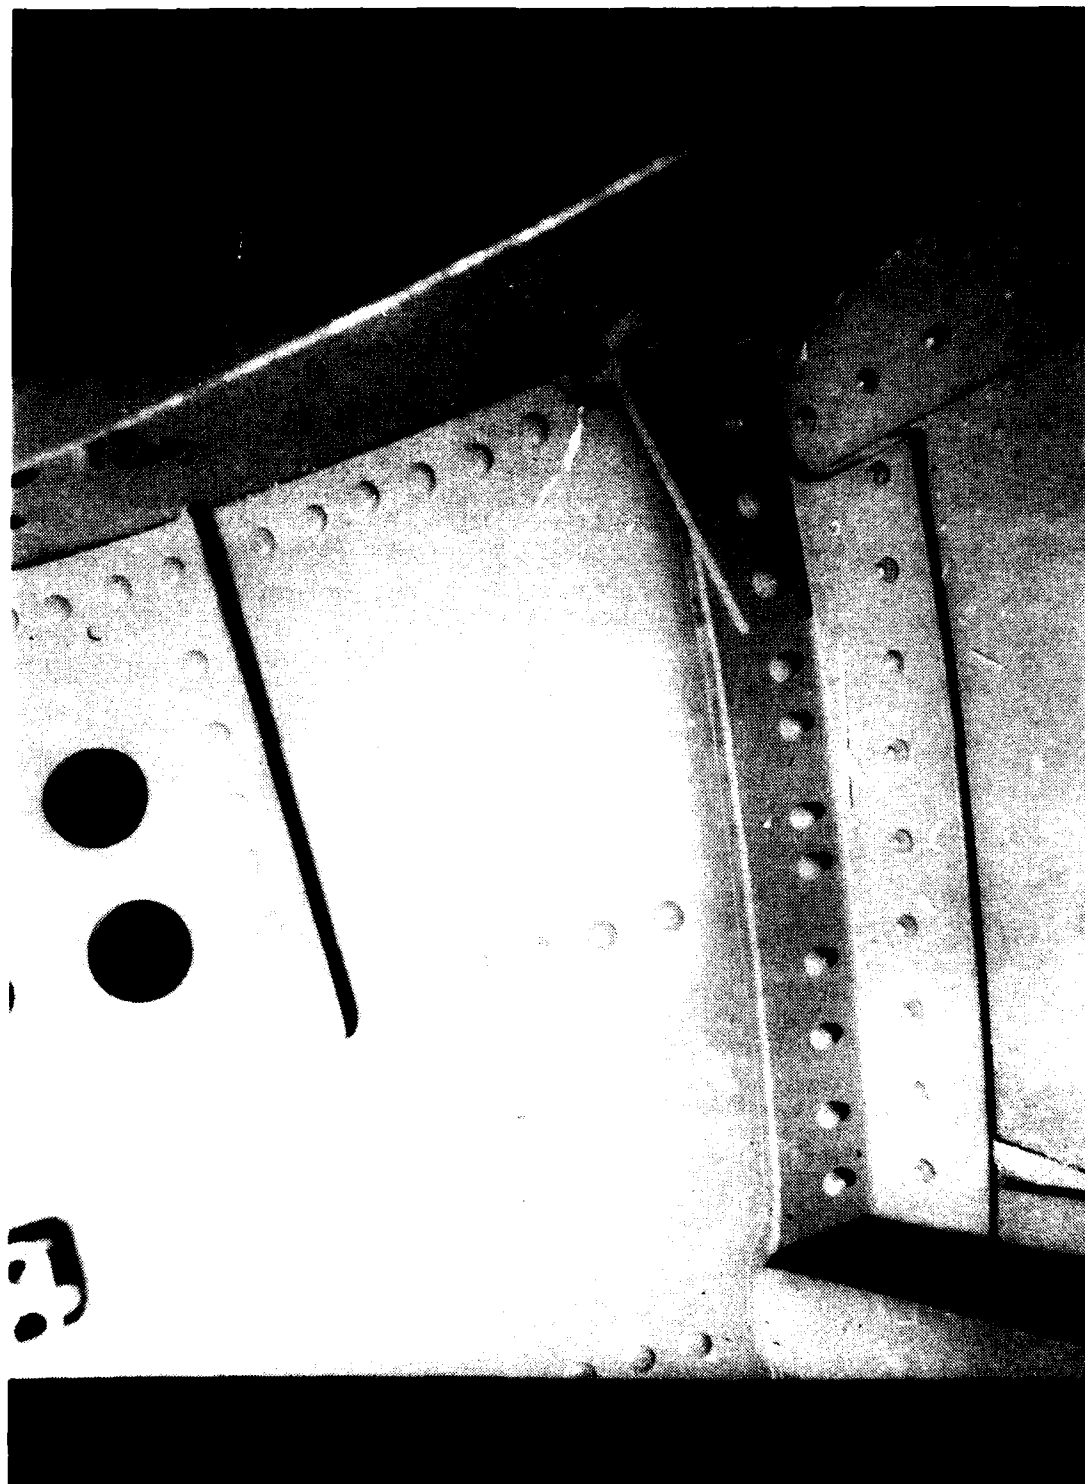
Figure 30. Crack in Engine Shroud

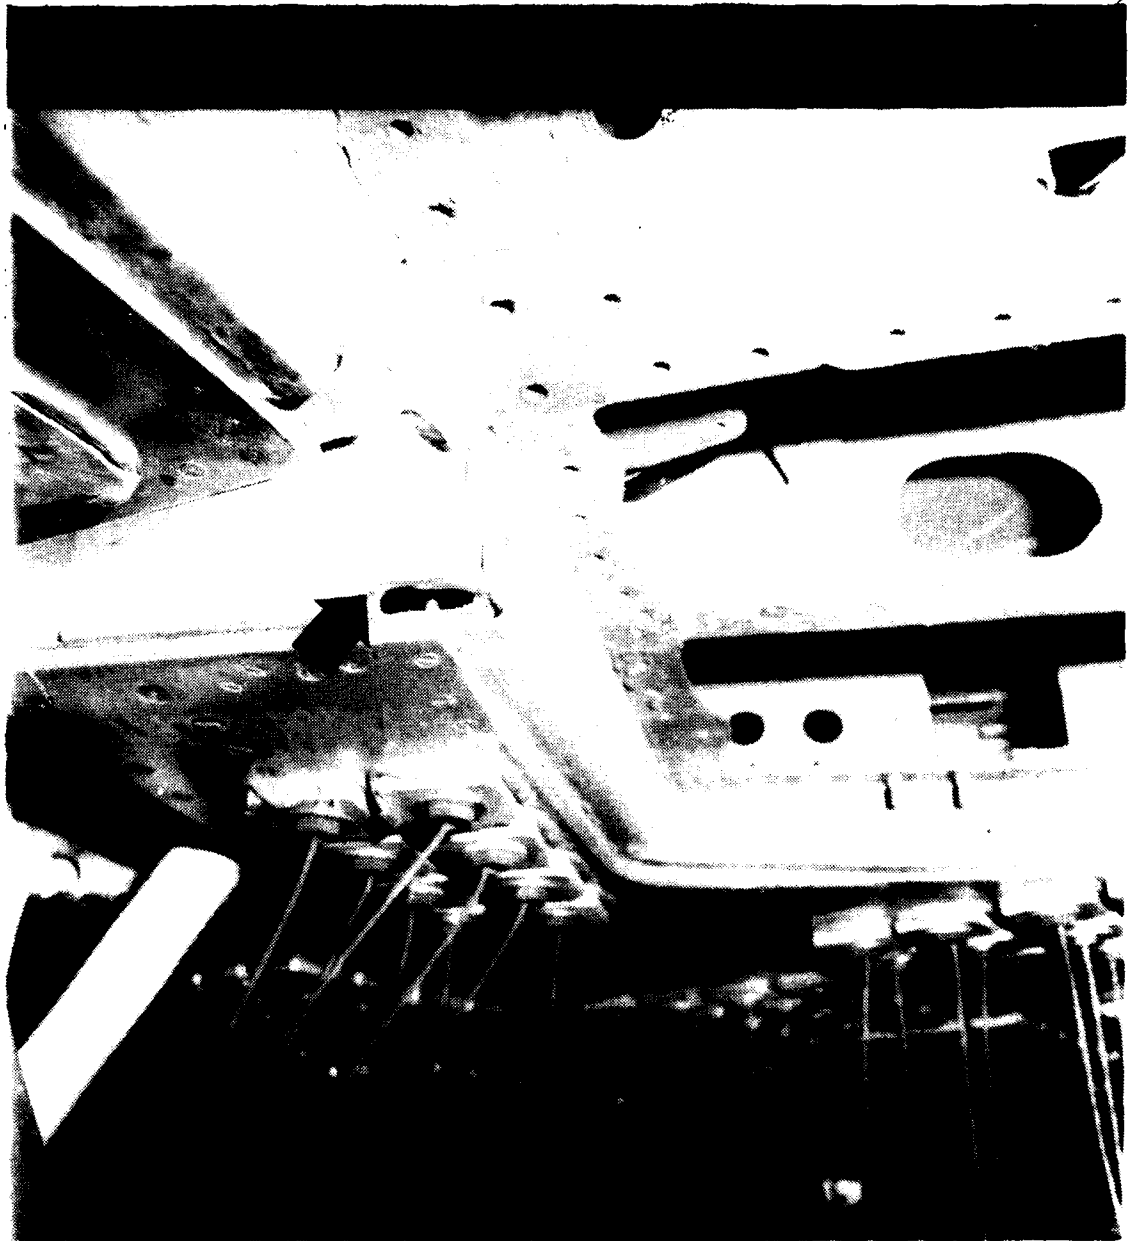
Figure 31. Cracks in Speed Brake Tunnels

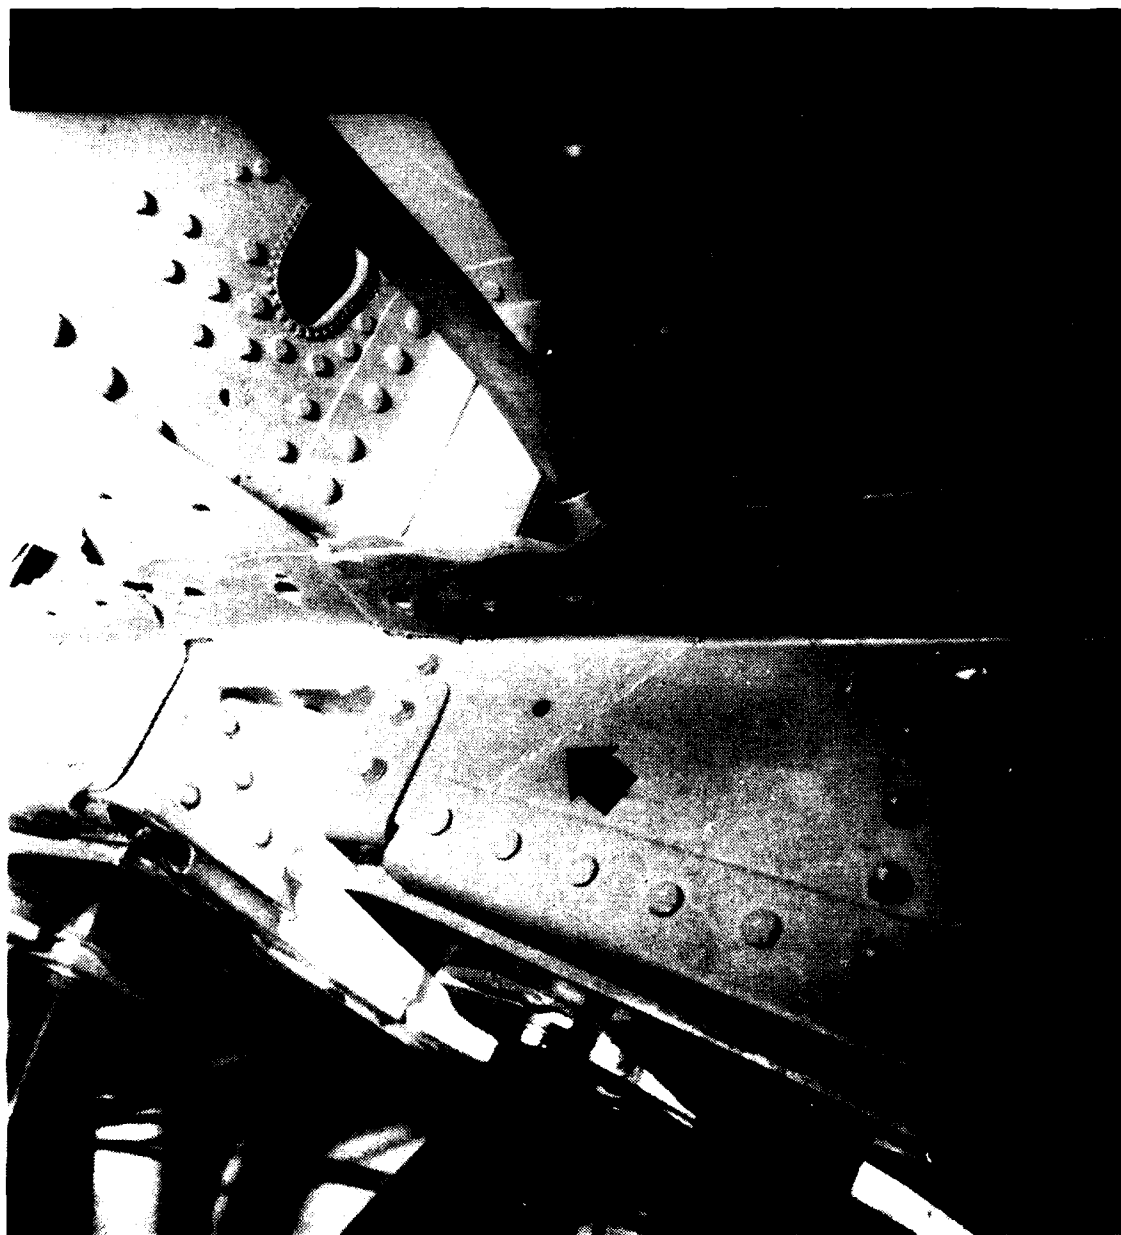
Figure 32. Failure of Speed Brake Enclosure

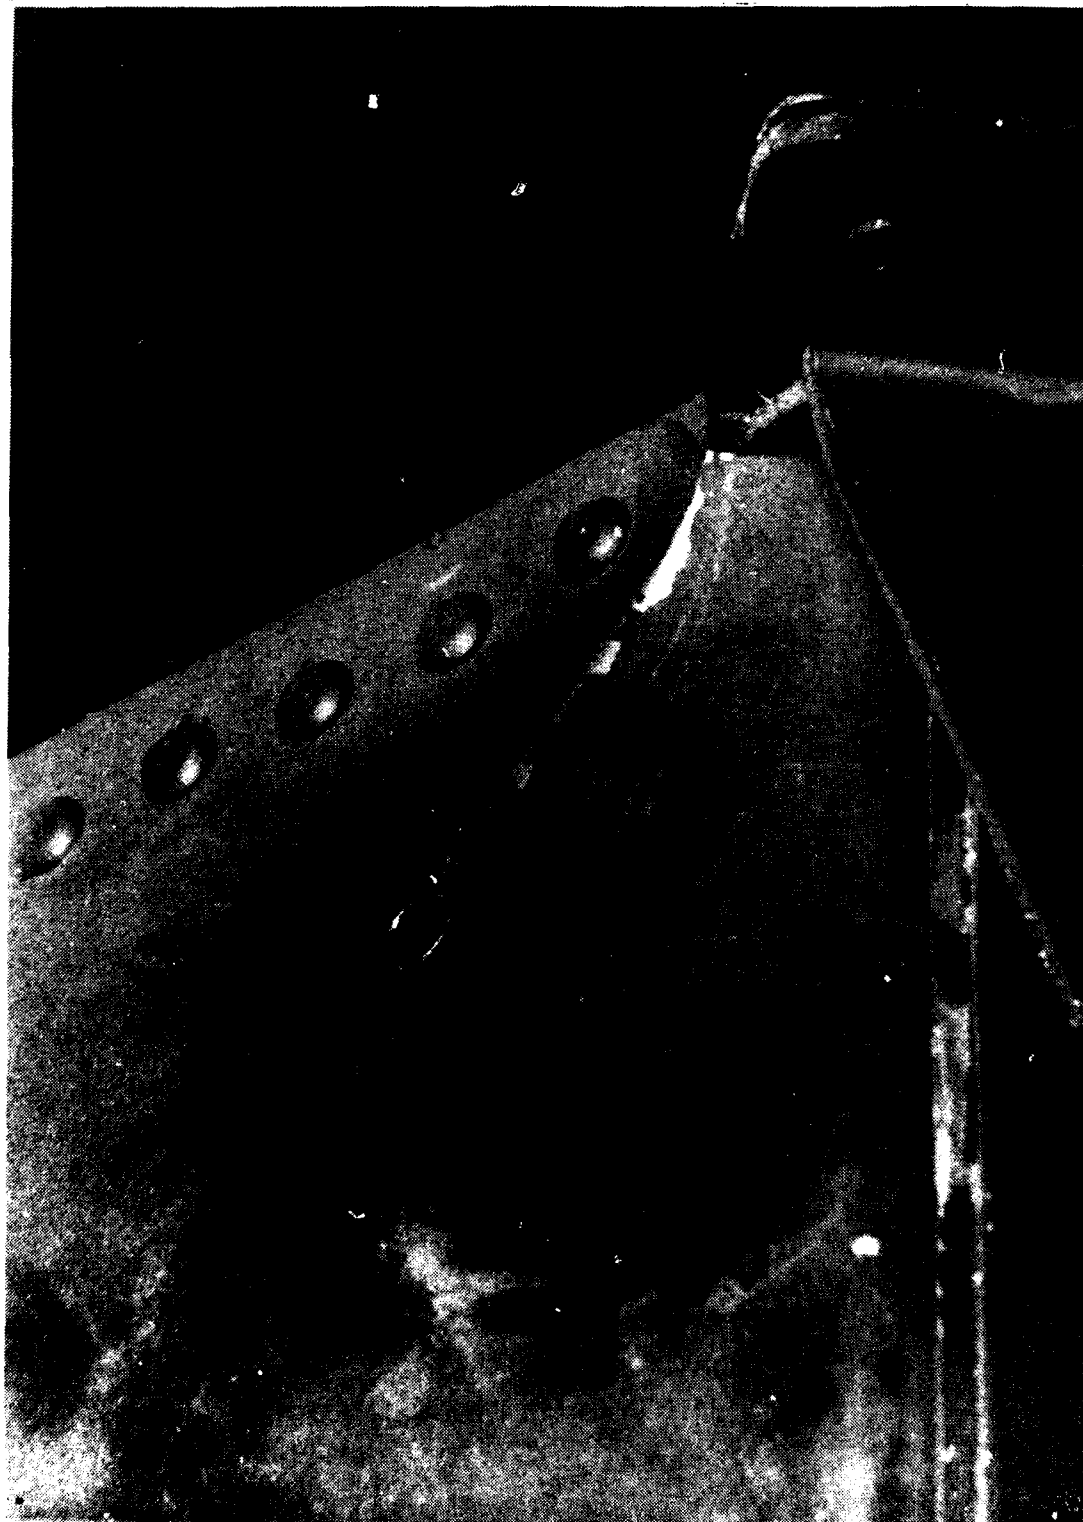
Figure 33. Crack in Shroud FS-332

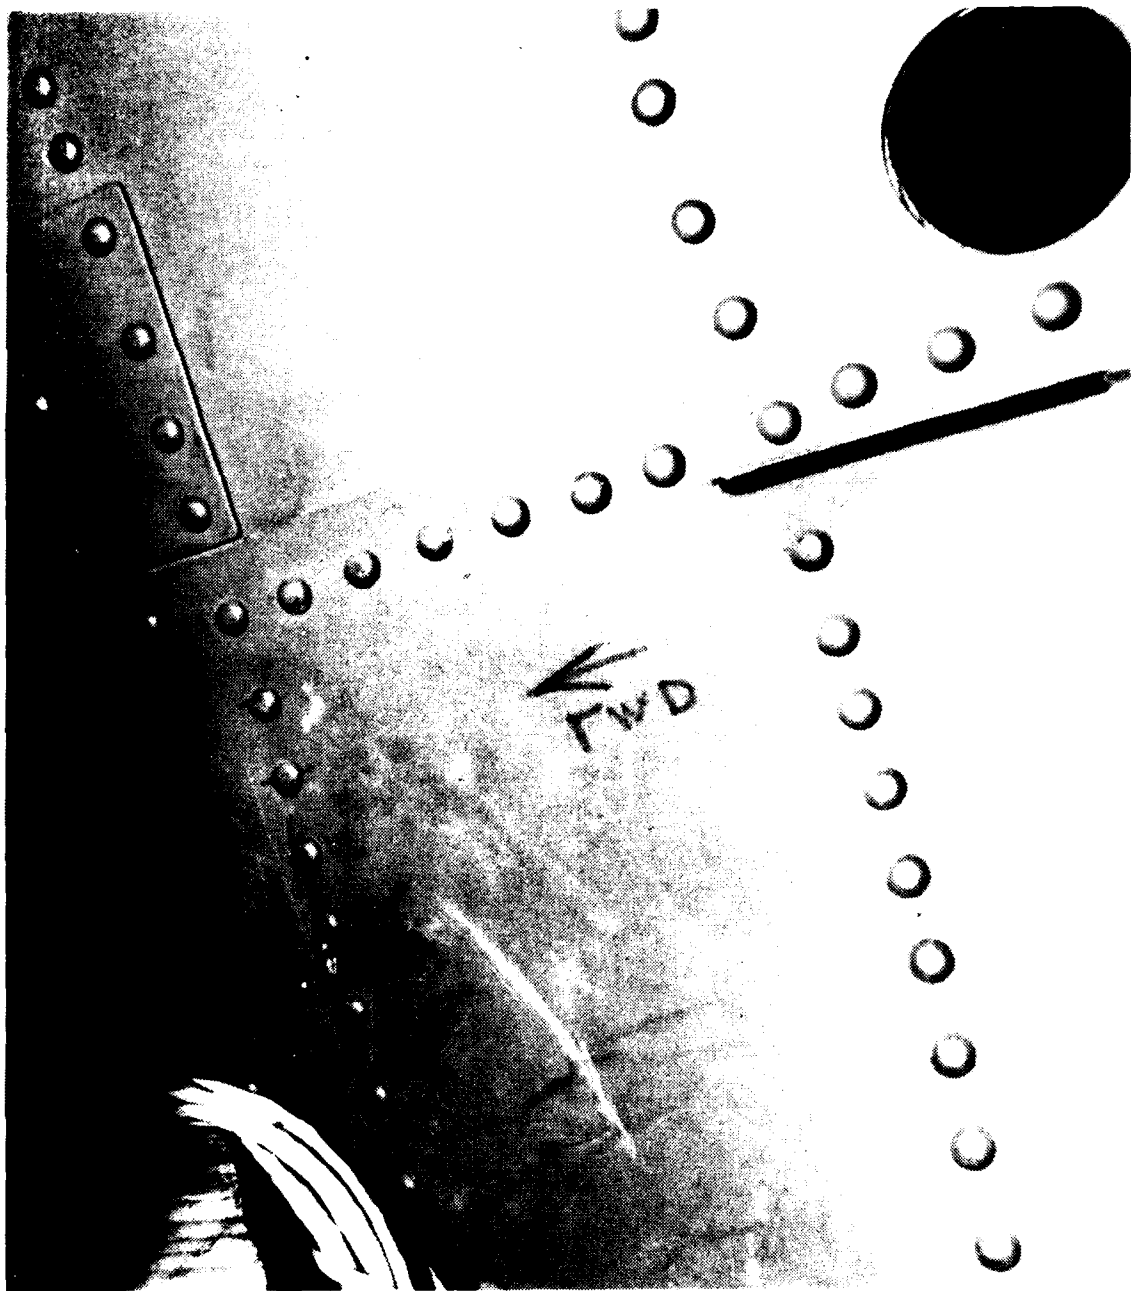
Figure 34. Crack in Fire Wall FS-318

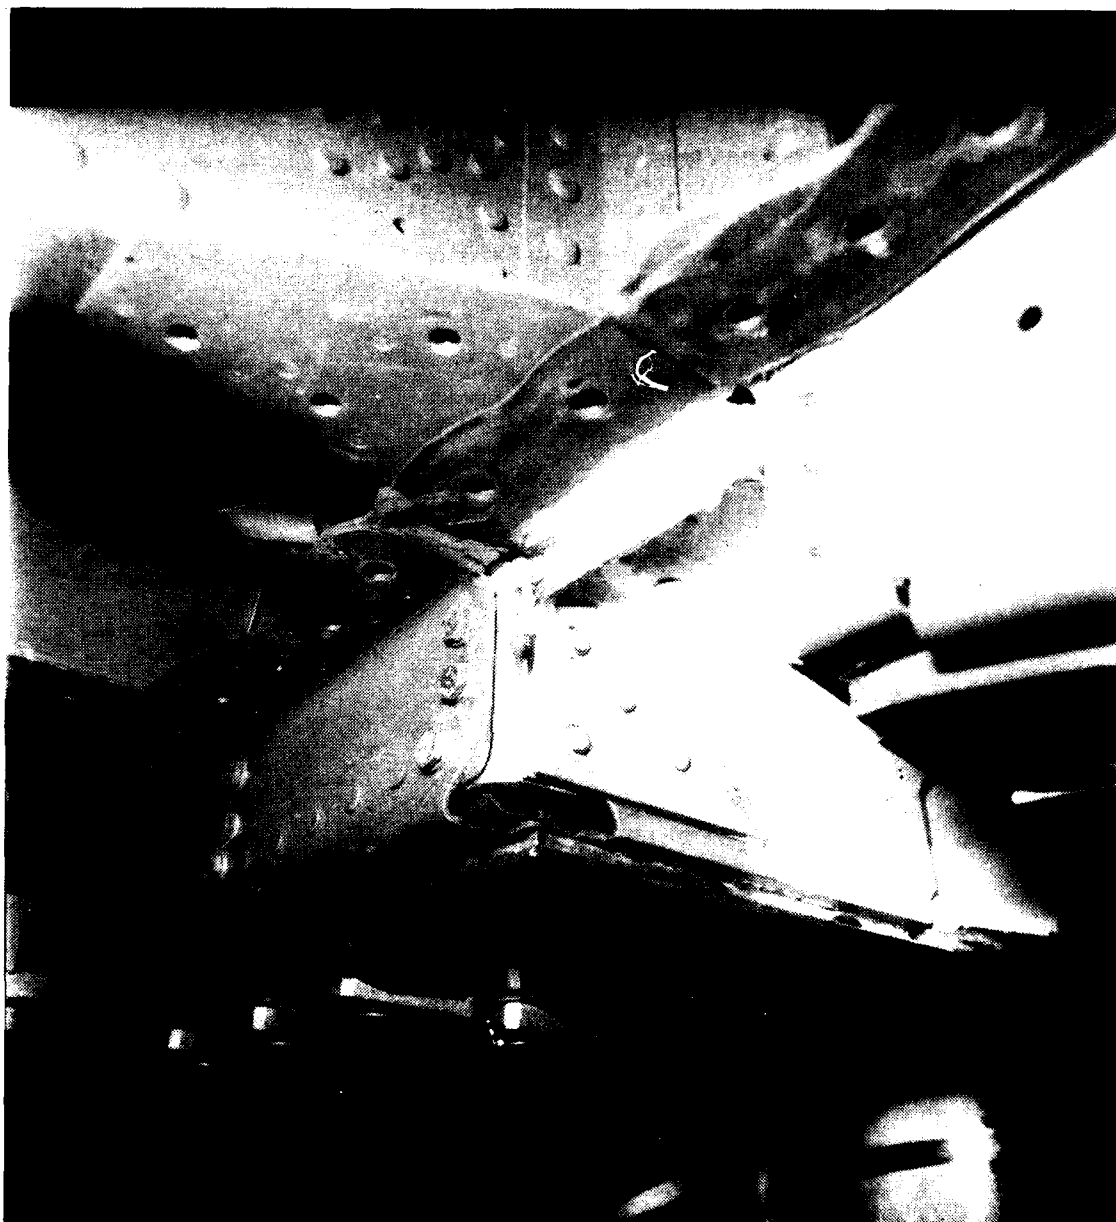
* 8000	<u>Crack in Both Left and Right-Hand Inboard Trailing Edge Flap Up-Stop Fittings (32-32506-301 & - 302)</u>	Replaced Fittings.
8000	<u>Crack in Outboard Speed Brake Tunnels Left and Right Wing (32-11215-15 & 16). Crack first found at 6000 hours did not lengthen (Figure 35).</u>	No Action Taken.

Figure 35. Crack in Speed Brake Tunnels

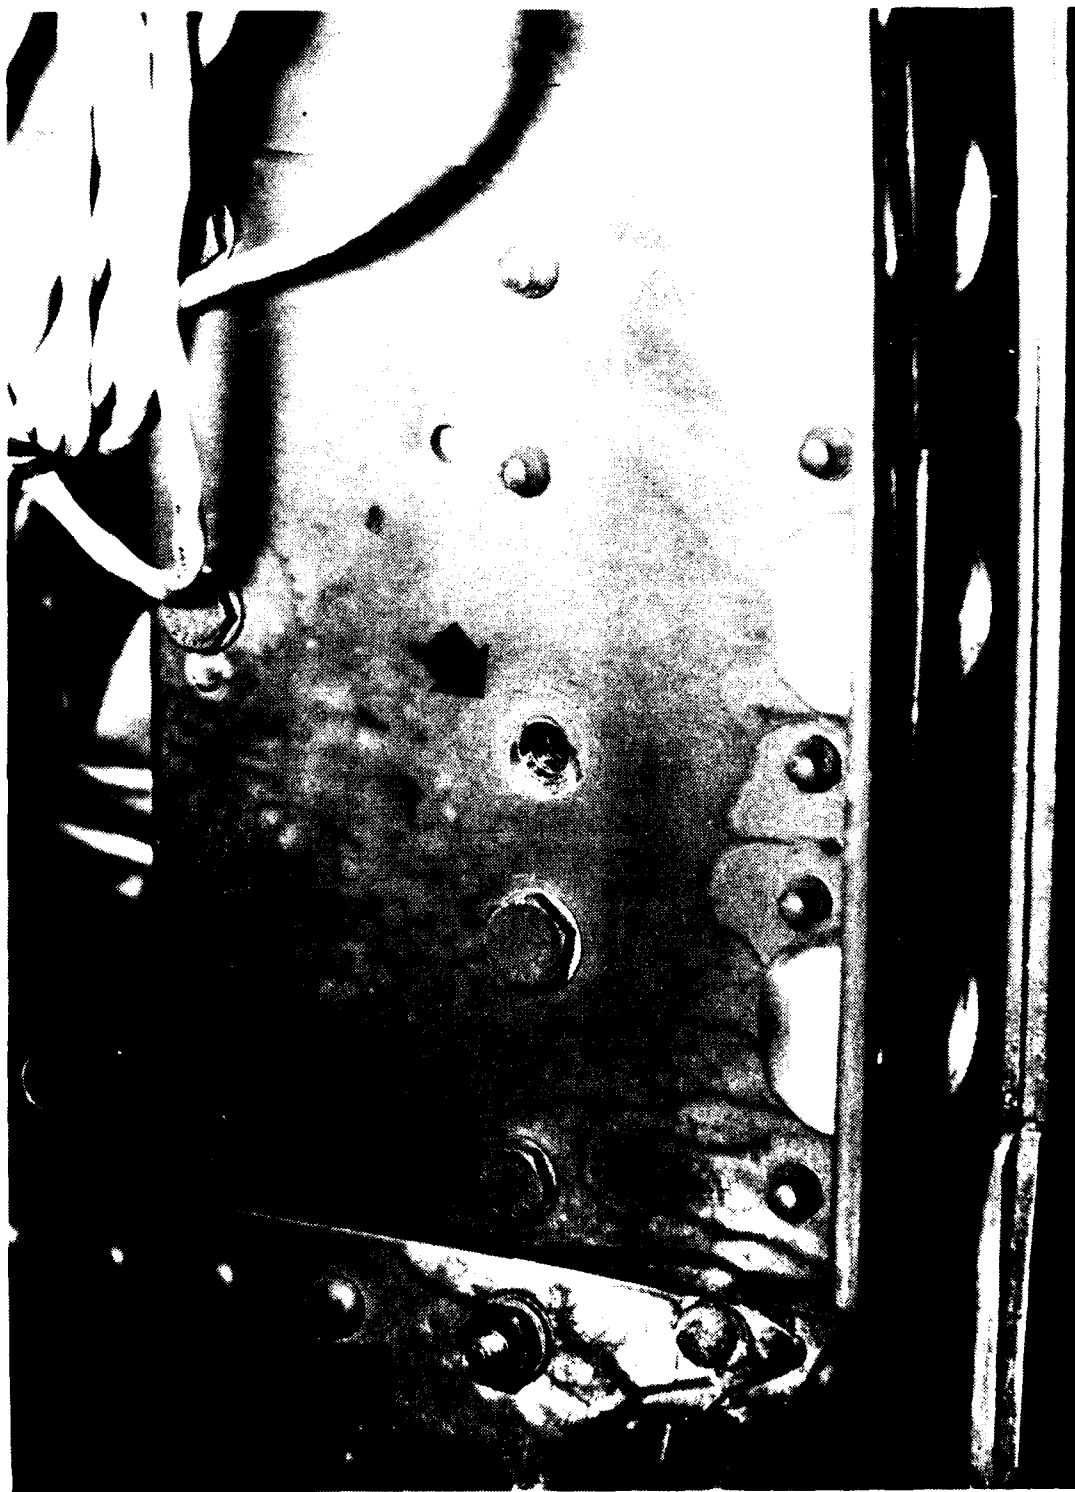
Figure 36. Failure of Fastener Tying Dogbone to Fuselage
Vertical Wall

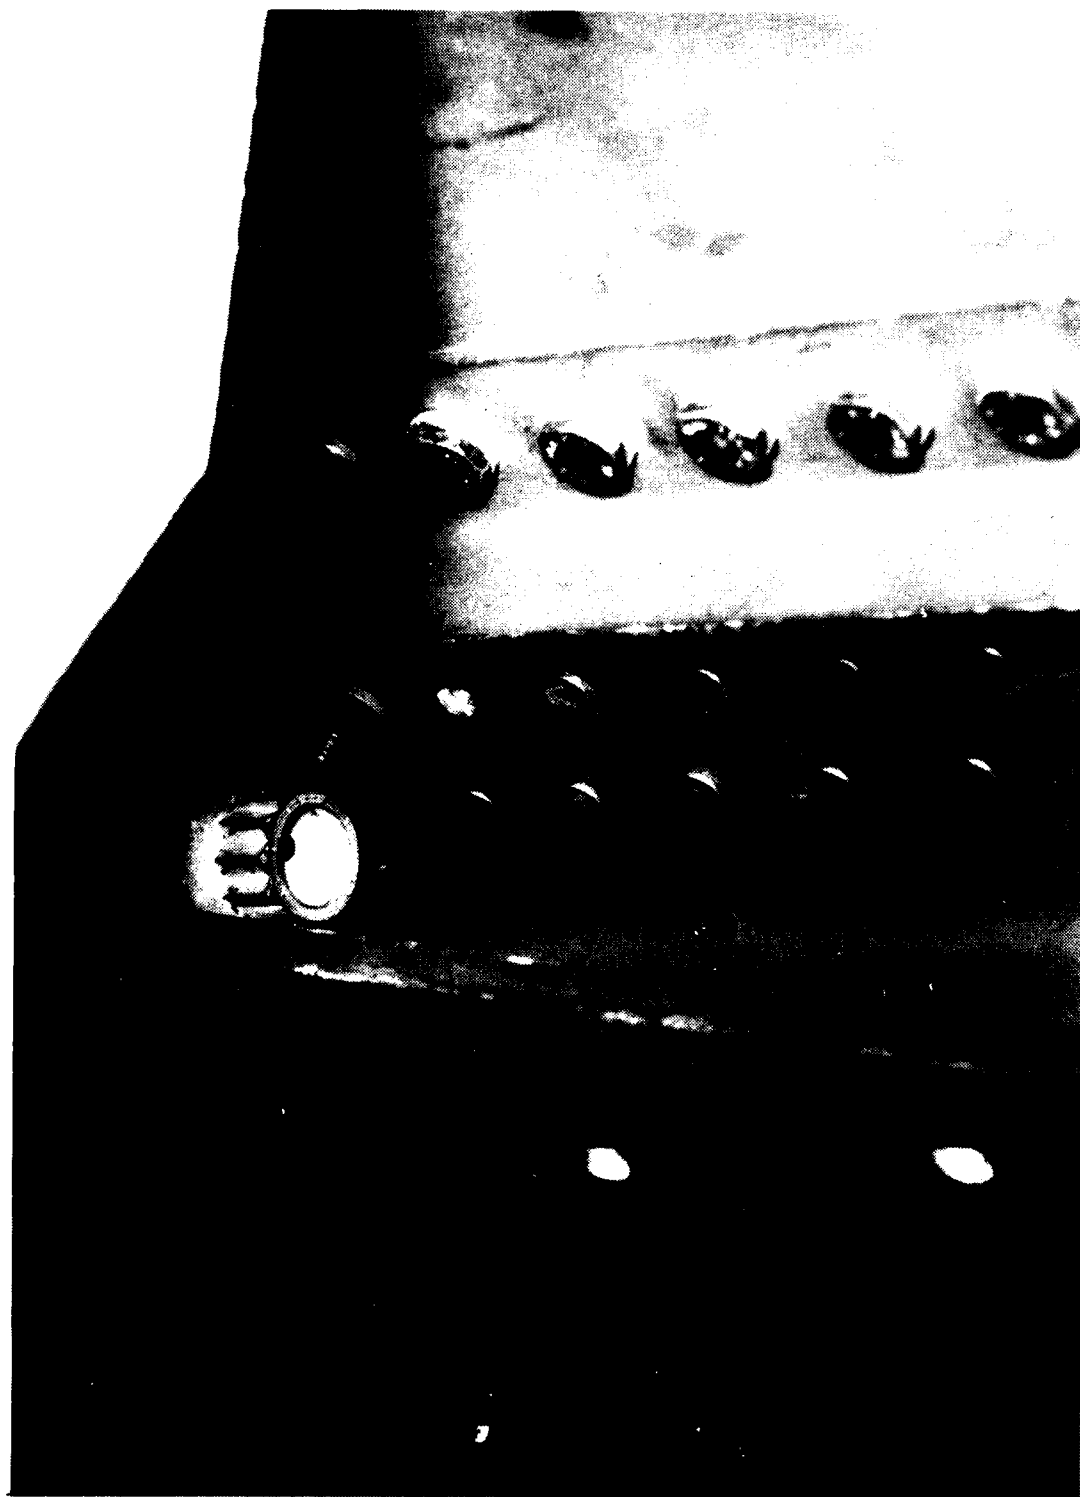
Figure 37. FS-249 Fastener Missing

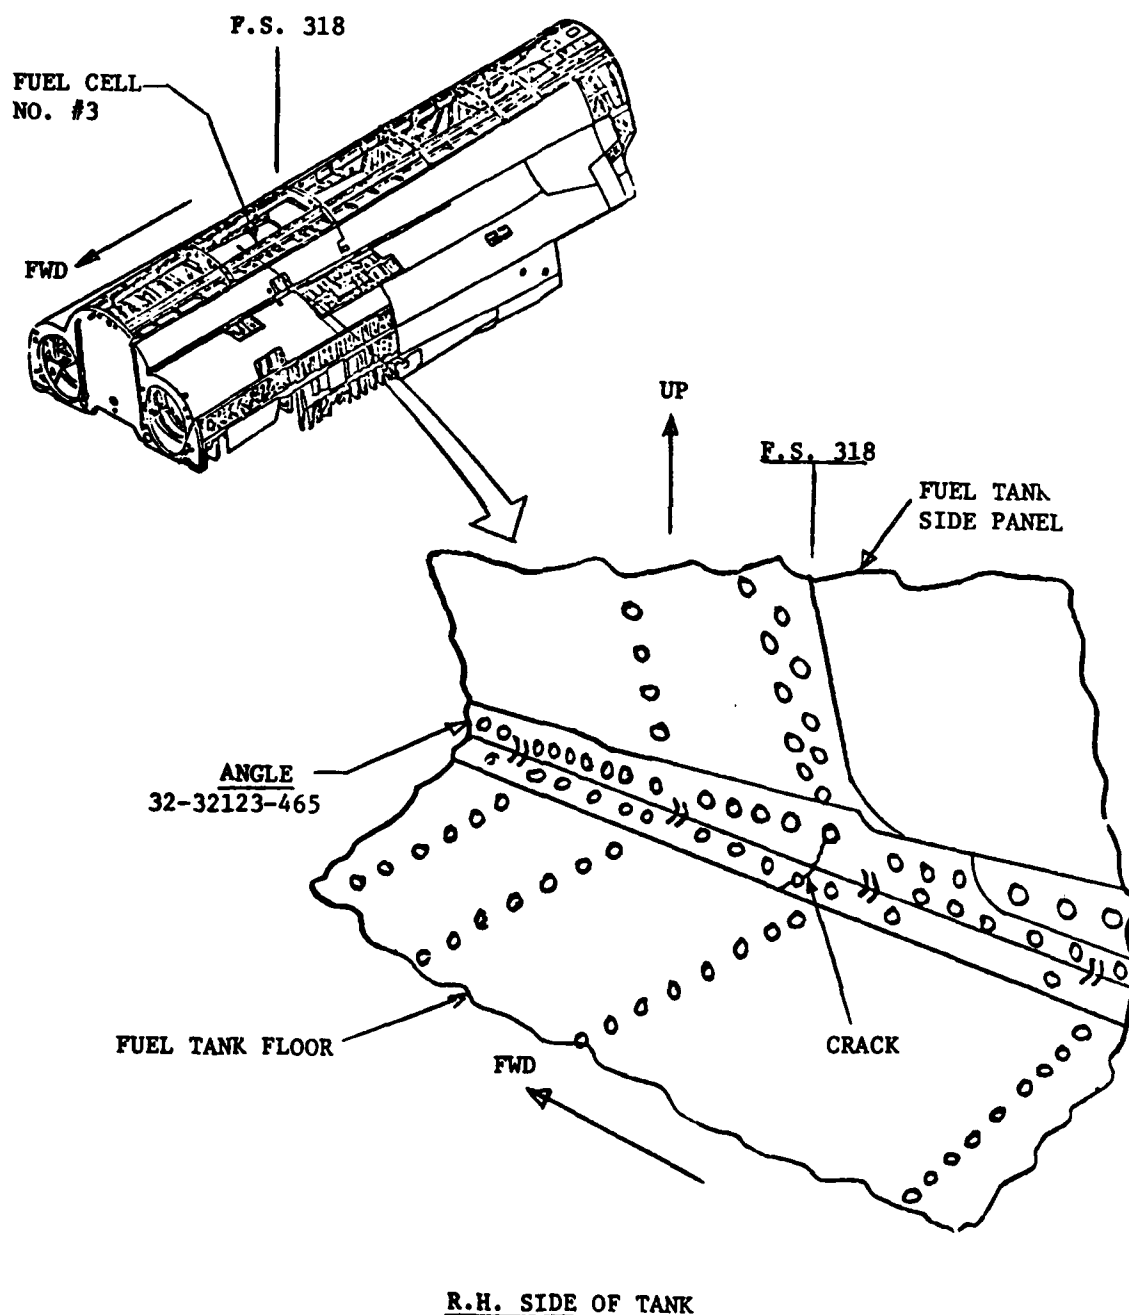
#3 FUEL TANK ASSEMBLY
32-32123-321

* 13,818	Crack Propagating from Fastener Hole in 32-32123-465 Angle Mating R/H Side Panel and Floor of # 3 Fuel Tank. (Figure 41).	Replaced Angle.
13,818	Crack in -143 Former that is Part of 32-32006-137 L/H Frame Assembly.	No Action Taken.

Figure 41. #3 Fuel Tank Cracked

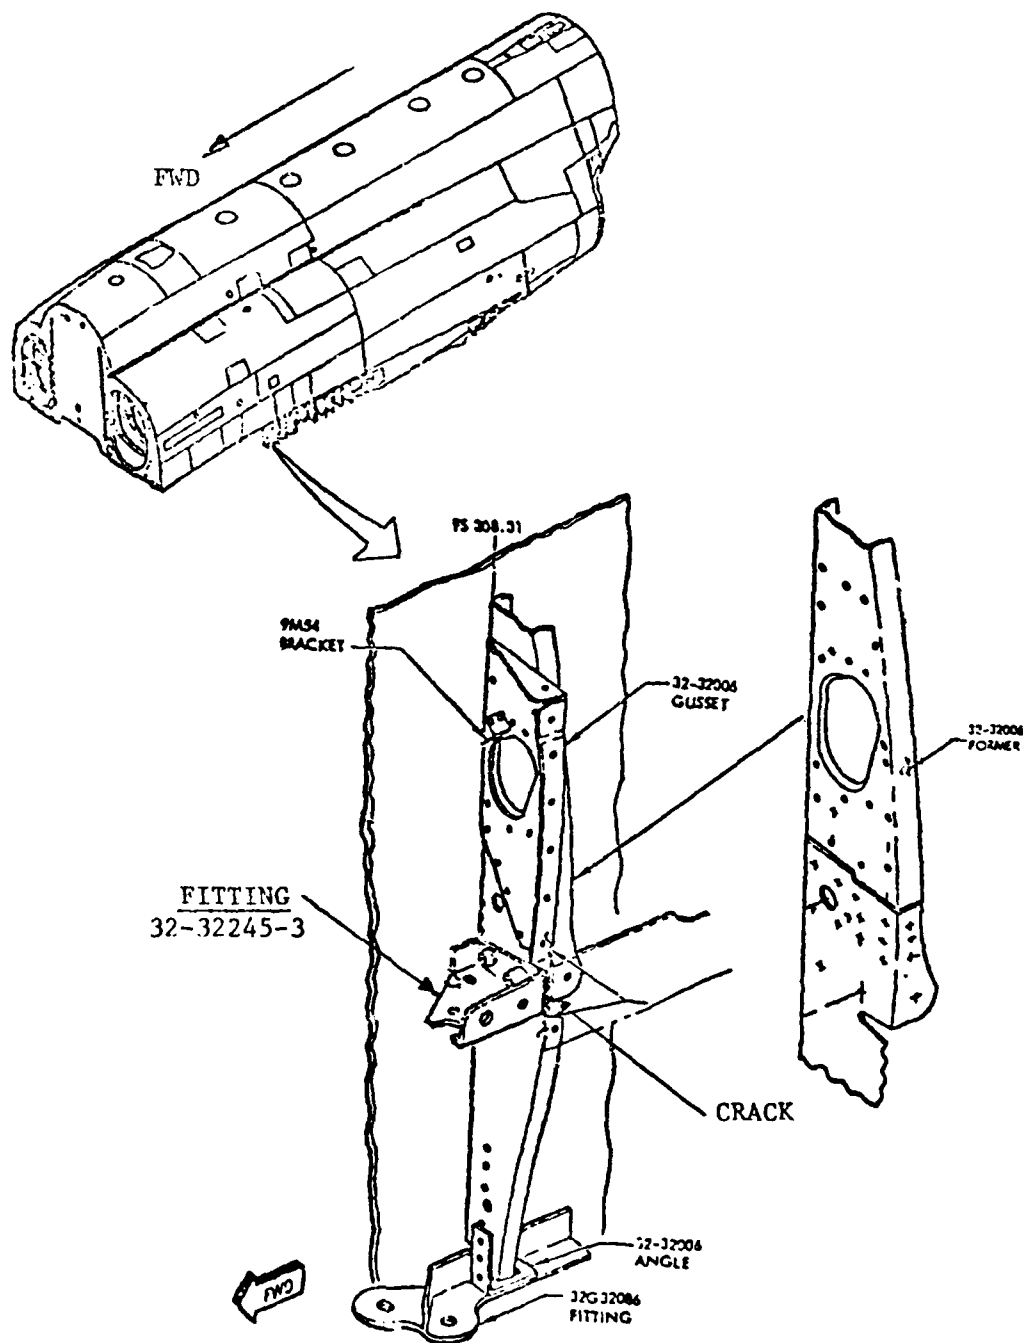
FITTING - WING PAD TO F.S. 308.31 ATTACH
32-32245-5

<u>SPECTRUM HOURS</u>	<u>DESCRIPTION OF FAILURES</u>	<u>DISPOSITION</u>
13,818	Crack in 32-32245-5 Fitting Tying Wing Pad to F.S. 308.31 Frame. (Figure 42).	Replaced
13,818	Fastener Missing Tying Front Spar to the B.L. 34 Shear Web at F.S. 249.65 on R/H Side of Aircraft.	Fastener Replaced.
13,818	32-50025 Eyebolt Tying Gate to Body of the 32-50043 Aft Inboard Engine Mount. (Figure 43).	Replaced
13,818	One of the Four Bolts Tying 32-50014-301 Forward Engine Mount Pad to the R/H Engine.	Replaced
*13,818	Cracks in 32-11215-16/-18 Tunnel Angles and in 32-11212-84 Aft Closure Angle. (Figure 44).	Replaced 32-11212-84 Angle. No Action Taken on 32-11215-16/-18 Angles.
13,818	Crack in Fire Wall Shroud Found at 10,000 Hours had Propagation Past Stop Drill Hole.	Stop Drilled with 3/8" Hole.
*13,818	Hydraulic Access Door Hinge Half Tied to Fuselage Cracked.	Replaced
*13,818	Fixed Bellmouth Rings Cracked on Both Sides of Aircraft.	Replaced

Figure 42. Wing Pad to FS-308 Frame Cracked

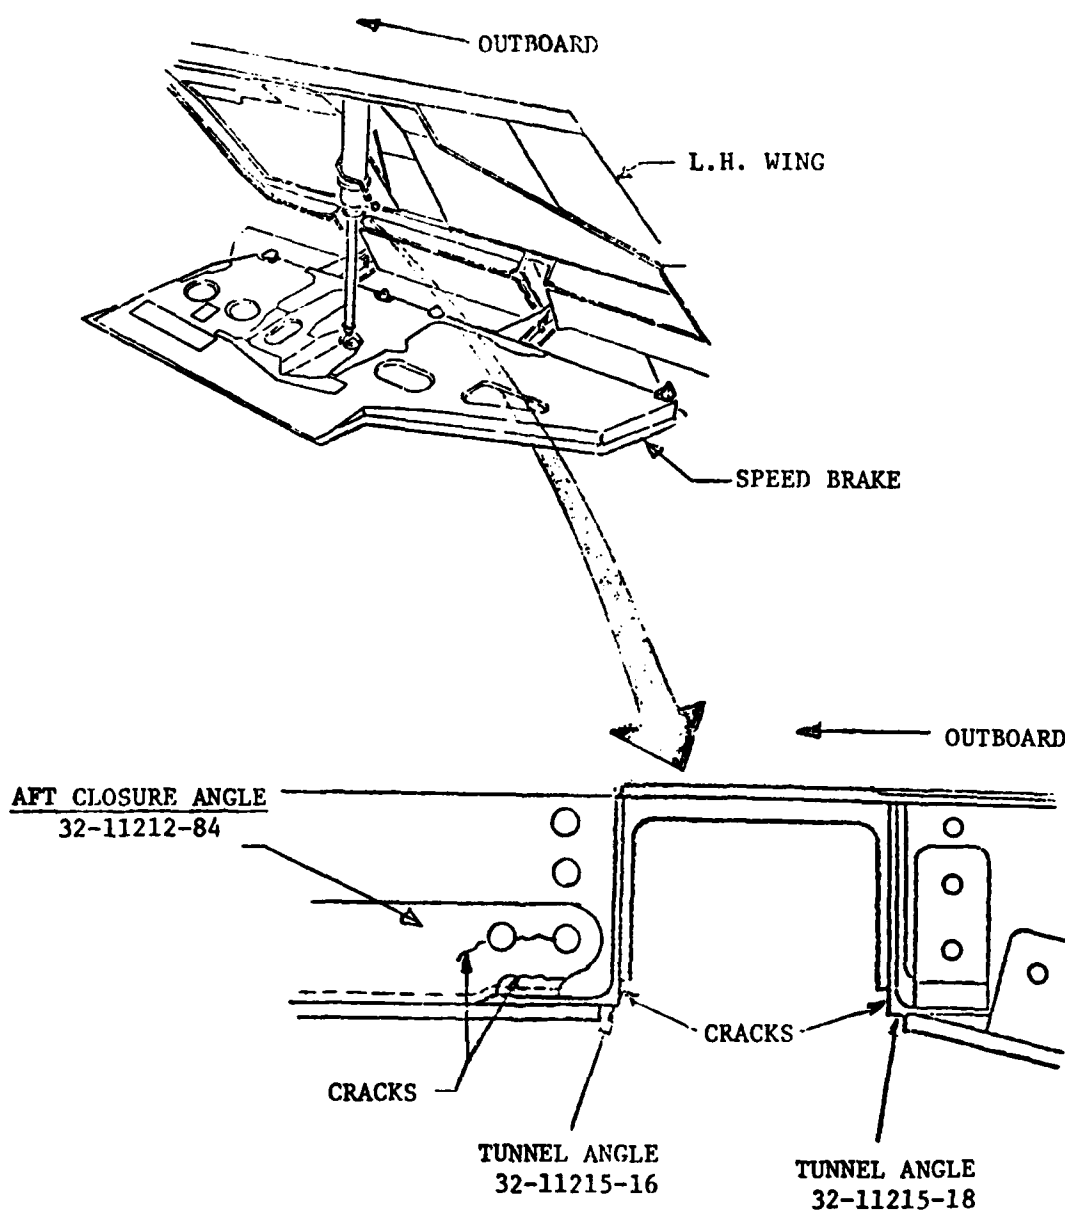
OUTBOARD SPEED BRAKE TUNNEL ASSEMBLY
32-11215-52

Figure 44. Speed Brake Tunnel Angles Cracked

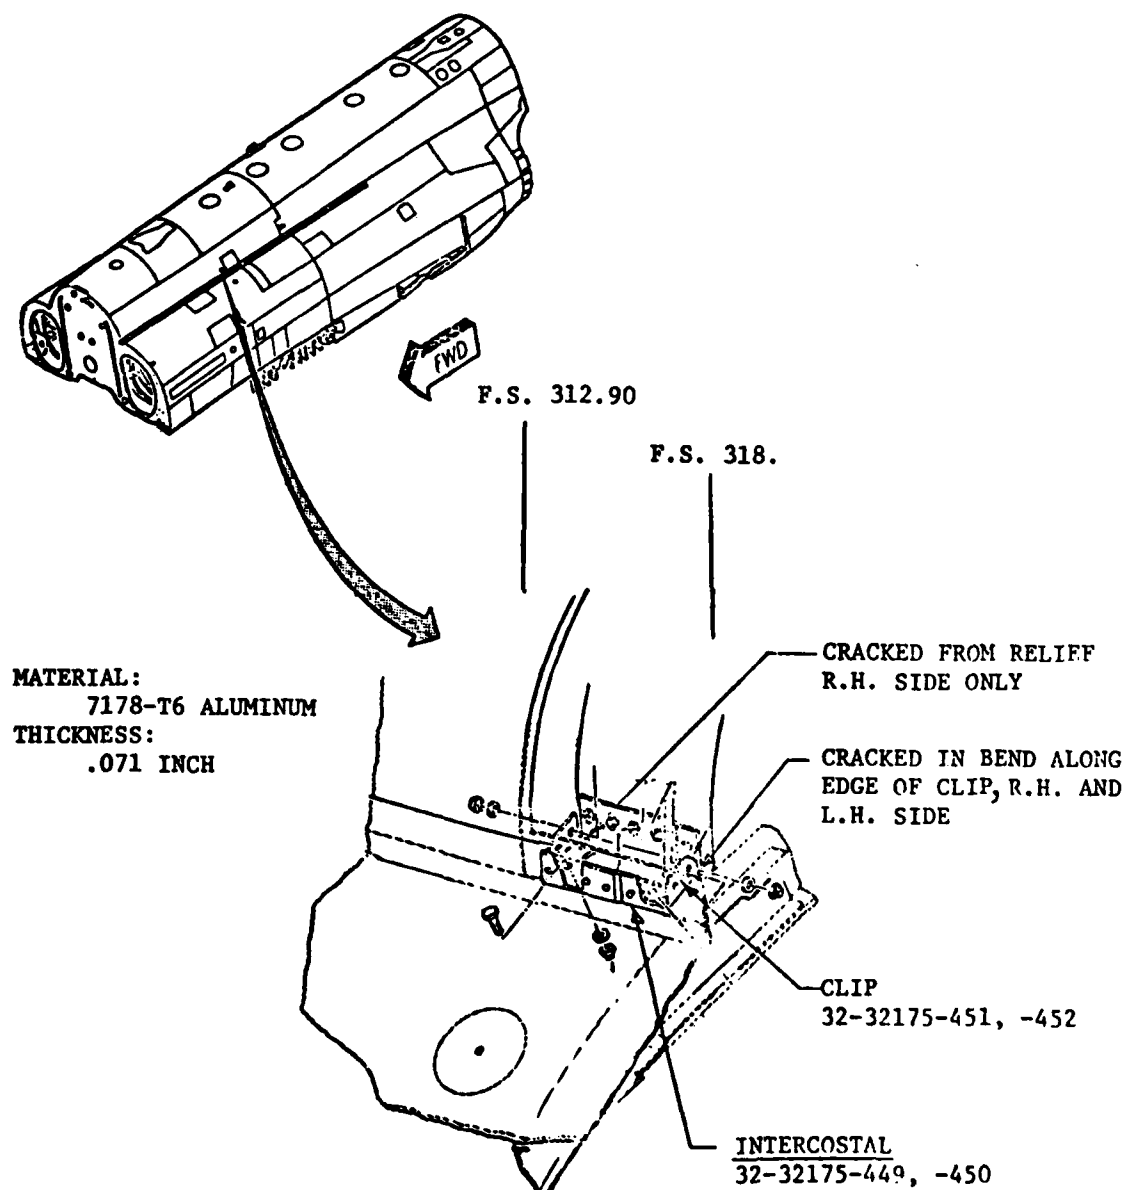
INTERCOSTAL ASSEMBLY, F.S. 312.90 TO F.S. 318
32-32175-449, -450

Figure 45. Intercostal FS-318 Cracked

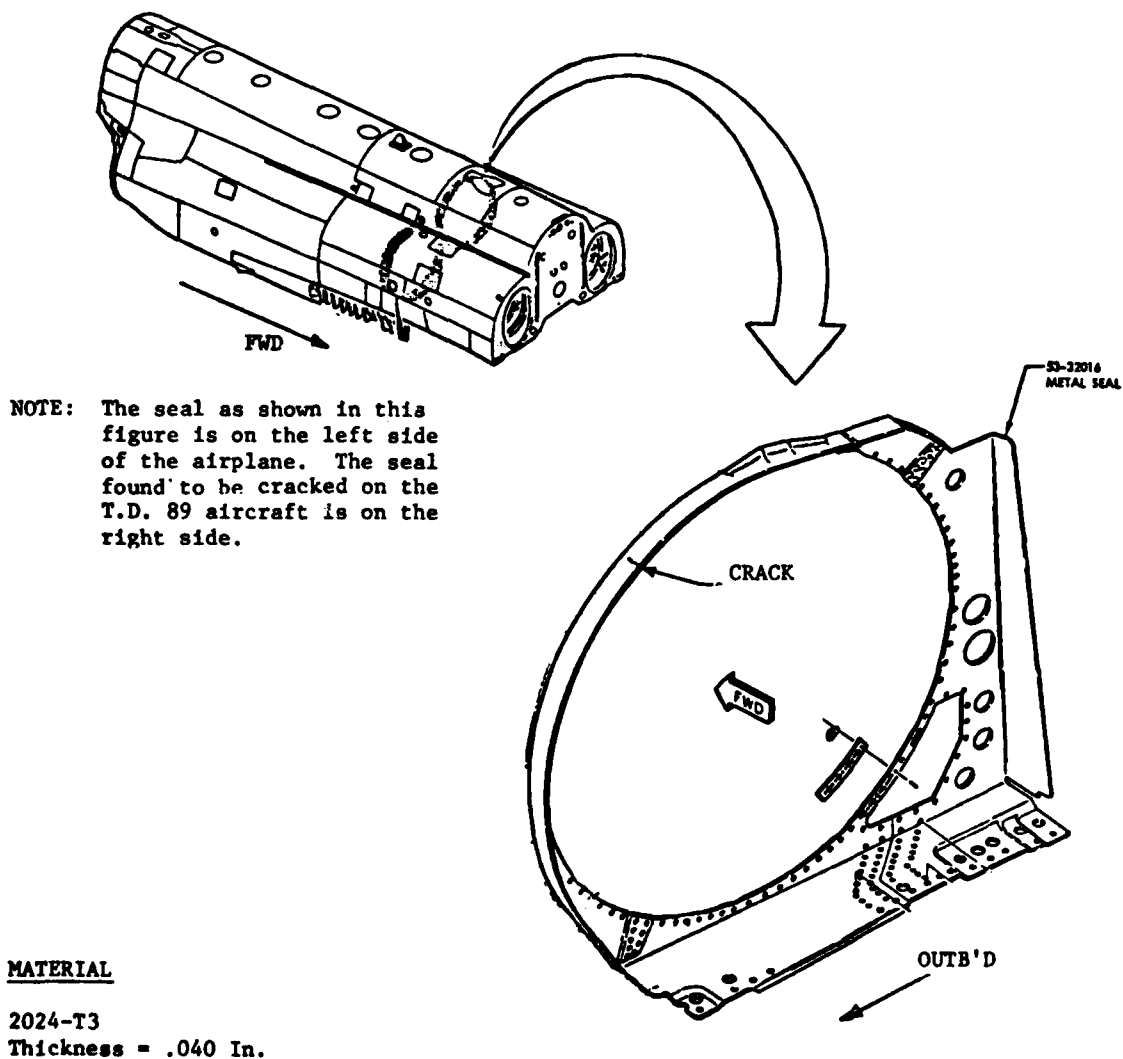
DUCT SEAL AT F.S. 303
53-32016-134

Figure 47. Duct Seal Cracked
